10th and Yamhill Parking Garage Study and Design Recommendations

Executive Summary

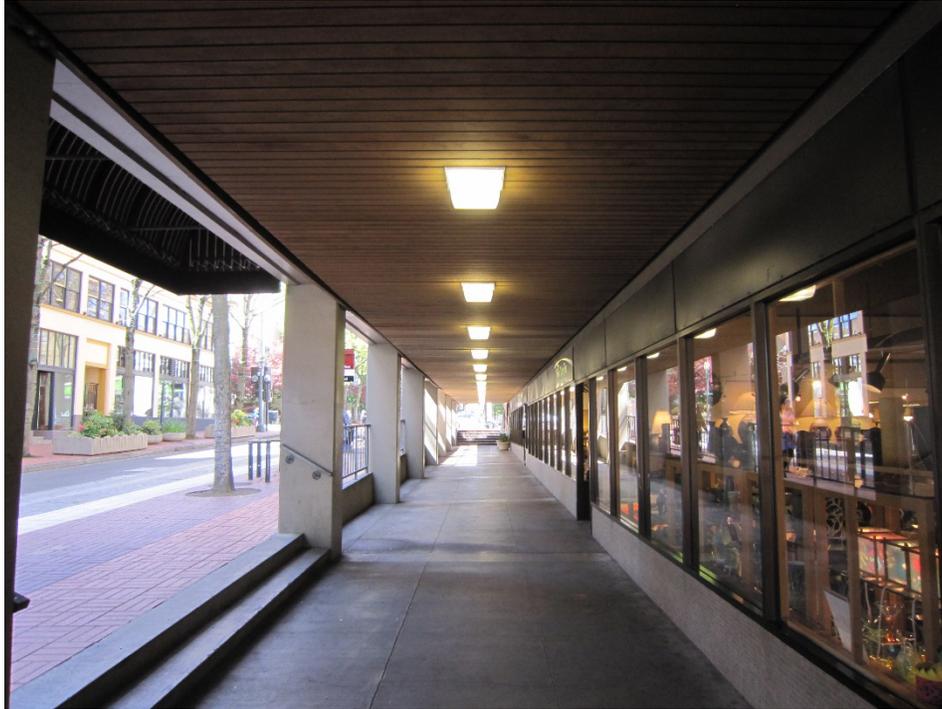
Existing colonnade at Yamhill Street. This walkway and the adjacent storefront sink further below Grade as one walks from east to west on Yamhill Street. As a result this and due to the limited of Connection between the sidewalk and this walkway, it is very difficult to see the retail displays.

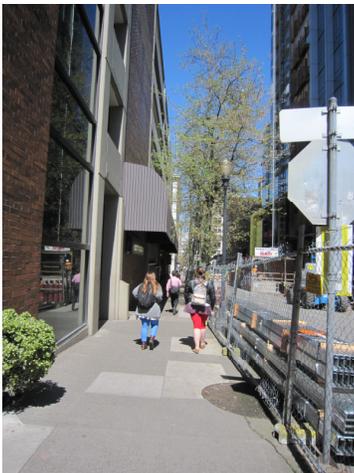
Sidewalk on SW 9th, looking north. There is a great deal of slope along this side of the building and floor elevations vary between 69.5' and 75.5'.

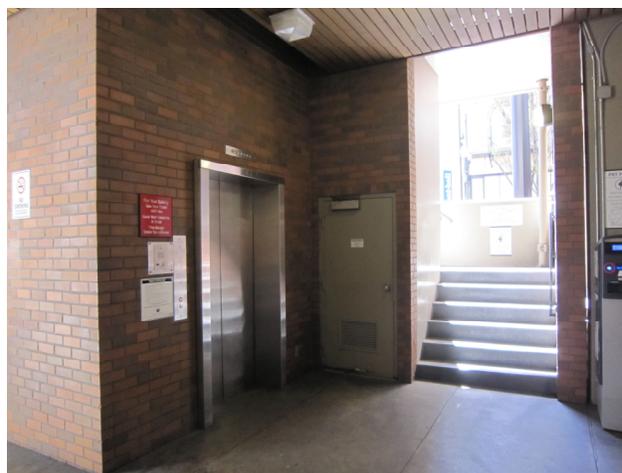
Elevator and stair lobby located at SW 9th and SW Yamhill. The position of the stair and elevator structure blocks view of the retail entrance from Director Park.

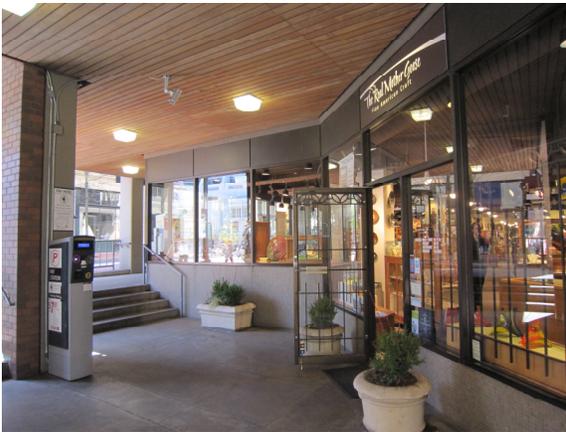
Entrance to the Real Mother Goose at SW 9th and SW Yamhill. Due to its location within the stair and elevator lobby and partially below grade, this retail entrance is obscured from the street

In order to provide access to each retail space, the grade directly outside the space and along the accessible route to it will need to be modified to allow for proper cross slopes. The existing entrance to the Real Mother Goose display window on Morrison Street is recommended to be moved to the east to create another retail space of similar size to the others on that frontage. Due to existing grades at that location, the floor elevation should be raised throughout the space using a relatively lightweight system of concrete on metal deck, to allow the space to be reconfigured with the adjacent space to the east, if desired. This is also recommended at the space currently being occupied by Peterson's where the existing entrance is raised above the finish floor level requiring the use of a ramp once inside the door.

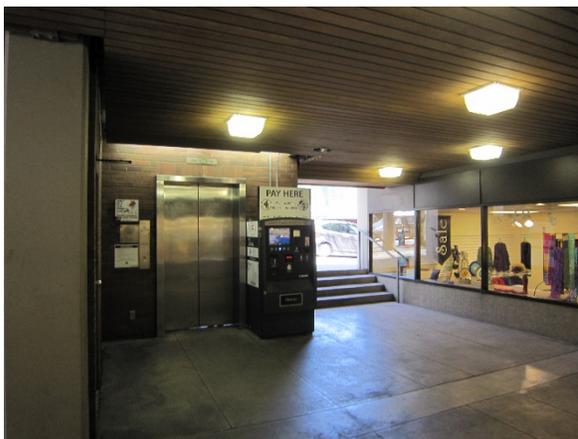
Existing Elevator Lobby at SW 10th and SW Yamhill. The space is dark and uninviting and cannot provide equal access for persons with disabilities. Access to this area is from the 9th and Yamhill corner.

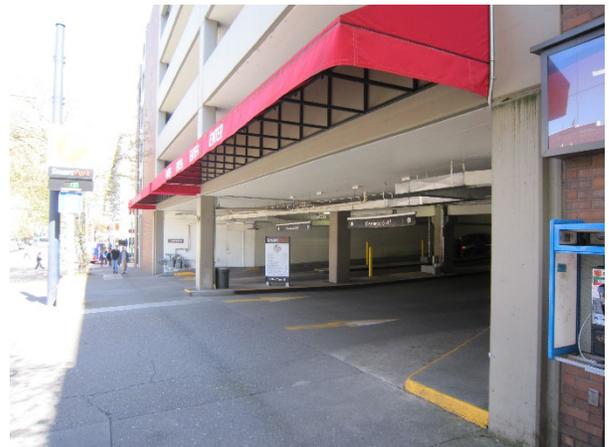
Existing vehicle entry on SW 10th. The canvas awning does not allow light to filter through, may be prone to color fading and requires cleaning and maintenance.

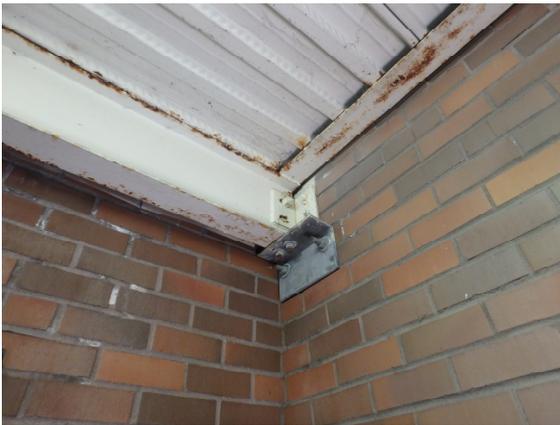
- **Waterproofing** — The current condition of the slabs and coatings at the parking levels is also consistent with the analyses in the Sargent and Bergen/ABAM reports. There are cracks in the concrete slabs and beams, some concrete spalling, corrosion at steel girders and some ponding. The areas of spalled concrete are not extensive enough to indicate corroding rebar. Traffic slabs in some areas are worn down and no longer provide the same level of protection as at the time of installation. Areas of corroded steel are minor and do not appear to be indicative of a systemic problem or degradation of the member's capacity.

Corrosion at steel members

- Remove chipped paint and corrosion from the steel framing on the upper two floors and repaint.
- Eliminate ponding on the 4th level by filling in the low areas with an appropriate leveling compound or add new drains at the low spots and connect to existing drain lines.

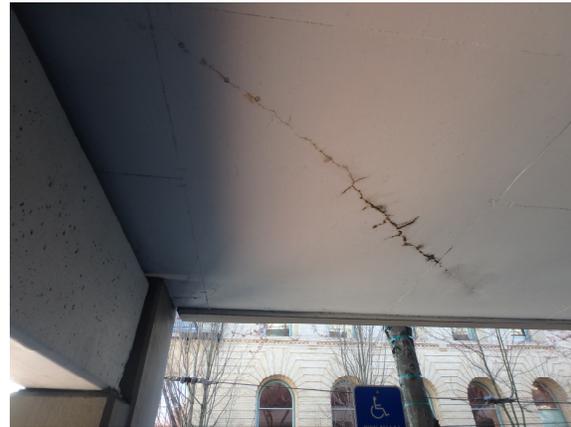
Crack visible at concrete slab.

- **Waterproofing and Repairs** – The project team's recommendations coincide with the Sargent Designworks report recommendations as the existing conditions have not changed significantly since the report was produced in 2014. These include:
 - Apply a traffic coating or sealer on the floor slabs, possibly just at the drive lanes, or rout and caulk the individual significant cracks. The second floor would require a traffic coating over the entire slab to protect the retail space below.
 - Remove the existing sealant and re-seal at both side of the pourstrip.
 - Remove all unsound concrete, clean the reinforcing, and install an epoxy based cementitious repair mortar at spalled and loose concrete
 - Inject epoxy into the spandrel beams at cracks to prevent moisture getting to the reinforcing.

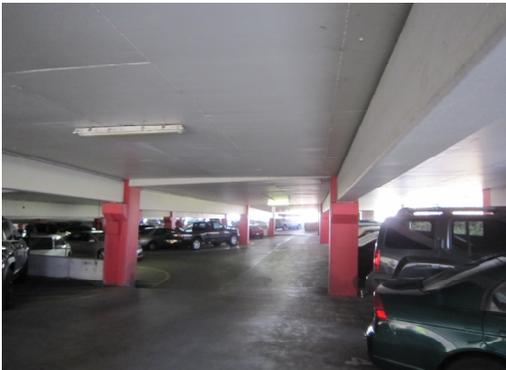
Light fixture at flat concrete slab ceiling

Electrical (Lighting) – In the garage, FFA recommends the existing fluorescent light fixtures be replaced with new linear LED with on/off drivers. Light fixture quantity could be increased to provide greater light distribution, particularly at the fifth and sixth floors where the steel beams may restrict light distribution, however the cost estimate associated with this study assumes replacing the existing fixtures close to their current quantity, with some additional fixtures included for flexibility. It is also recommended that the existing timeclock system be replaced with a new programmable lighting control relay panel in main electrical room on ground floor. Surface-mounted lensed linear fluorescent are recommended for the new restrooms and to replace the existing fixtures in the existing restrooms. In addition, wall switch occupancy sensors are to be incorporated to meet energy code and GFCI receptacles will be provided each new restroom.

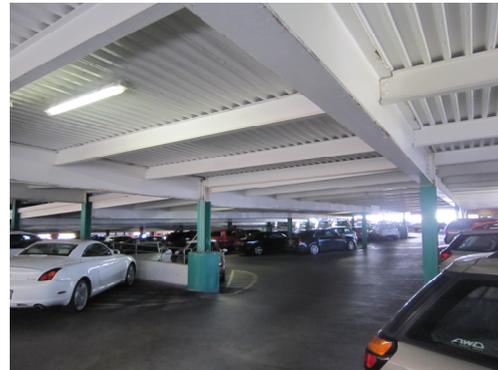
Light fixture at metal deck steel beam ceiling
